# 疑似钛过敏致早期种植失败伴周围组织坏死一例

李诗琪, 刘雁鸣\*

# Early Implant Failure with Peri-Implant Tissue Necrosis Suspected Due to Titanium Allergy: A Case Report

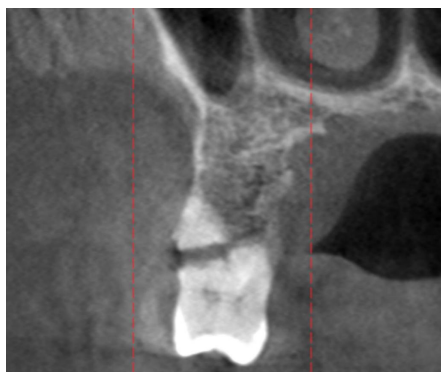
Figure 1. Preoperative CBCT of #16

图 1. 16 牙位术前 CBCT

周某, 女, 54 岁, 平素体健, 否认吸烟、饮酒史, 高血压病史, 服药控制可, 否认心脏病、糖尿病等系统性疾病。主诉“右上后牙咬合痛半年余”, 前来就诊寻求治疗方案。检查: 全口牙周情况欠佳, 16 伸长, 松动 I 度, 根面暴露, 探针可穿通分叉区, 叩痛(+), 17、22、27、37、47 缺失, 25、46 残根。CBCT 显示: 16 远颊根根折, 根分叉区低密度影像, 近中及远中颊根可见牙根外轮廓存在不规则、虫蚀状透射影(图 1)。16、25 根方骨宽度及高度充足, 22 缺牙位点骨宽度及高度尚可。治疗计划: 口腔卫生指导; 结合患者意愿及经济考量, 拟于 16、25 位点行即刻种植, 22 位点行常规种植, 46 拔除 3 月后行延期种植, 待骨结合完成后取模行全瓷修复。

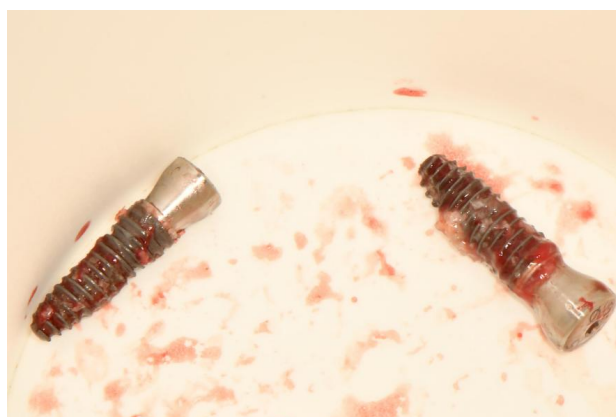
**Figure 4.** Removal of implants #22 and #25  
**图 4.** 取出 22、25 种植体
